13 Transportation Safety

Identification of the Most Hazardous Intersections in Franklin County

Greenfield Rotary Safety Analysis

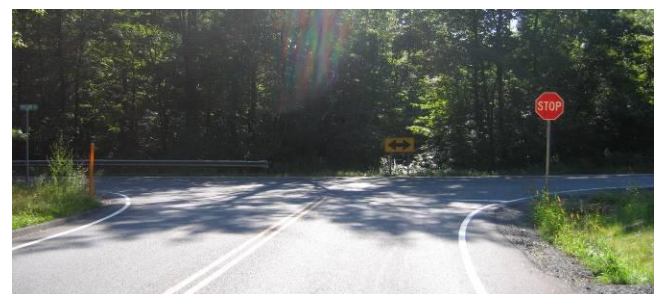
The intersection of Route 202 at Prescott Road, in Shutesbury (Ranking #9)

- **Route 202 at Prescott Road (Shutesbury).** The intersection of Route 202 at Prescott Road is not recommended to receive a RSA at this time due to physical limitations of the design of the roadway and surrounding site conditions. The rural nature of this roadway, among several horizontal and vertical curves, as well as the lack of pedestrian or bicyclist traffic indicated that there may be very few low-cost safety improvements which can be implemented at this location. Therefore, while this location should be studied in greater detail to determine the potential for safety improvements in the future, the RSA process does not seem to be the most beneficial medium for this location.

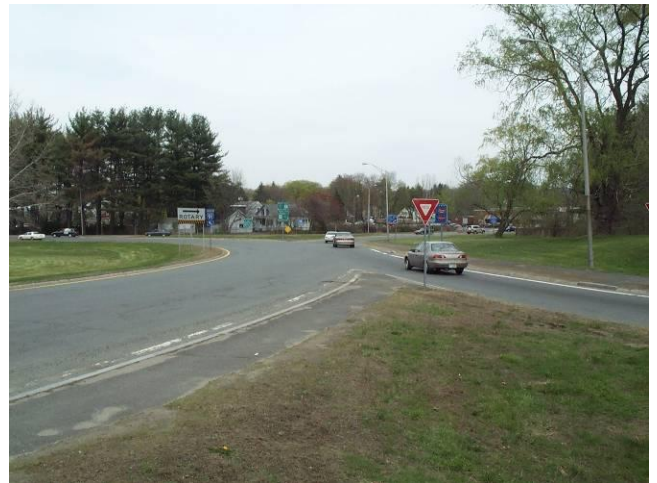
The Greenfield Rotary, prior to the implementation of safety improvements

In response to the Rotary's position as a top crash location, FRCOG staff approached MassDOT, who has jurisdiction over the Rotary, with the idea of exploring the design and implementation of a lane marking and signing plan to channel traffic more efficiently and reduce vehicle circulating speeds in order to improve safety and traffic flow. Crash and traffic count data were collected and analyzed, and it was determined that an additional entry lane should be added to the Mohawk Trail (Route 2 and Route 2A) approaches to reduce delays and, in turn, the probability of rear-end crashes. It was thought that adding the additional lanes to these two approaches would reduce the delays on the I-91 approaches and increase the number of gaps in the circulating flow for those vehicles to enter.

MassDOT undertook the design, and the New York State Department of Transportation (NYSDOT), who had successfully implemented similar improvements to rotaries under their jurisdiction, was consulted during the design process. The bulk of the changes involved adding pavement markings and directional signage, but some minor widening was required to accommodate an additional lane on the Route 2/2A approaches. In addition to the changes to the Rotary, pedestrian improvements were incorporated into the project, including filling in the missing portions of sidewalk between the Rotary and Newton street, bringing the existing sidewalks into compliance with ADA regulations and adding pedestrian activated signals to the Newton Street and Colrain Road intersections. The improvements were completed in the Summer of 2008.

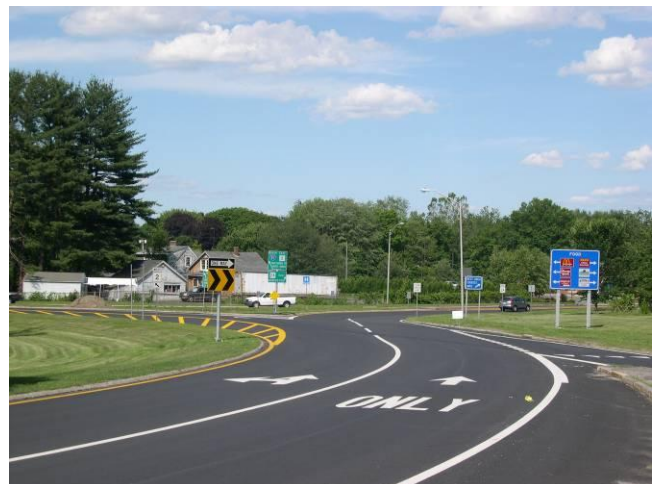
The Greenfield Rotary, after the implementation of safety improvements

The most recent available crash data was examined to monitor the effectiveness of the improvements at the Greenfield Rotary. As demonstrated in this analysis, many of the crash characteristics (i.e. type of crashes, weather conditions, etc.) of crashes occurring at the Greenfield Rotary remain unchanged before and after the safety improvements were implemented. A comparison of crash frequency, however, shows that there was a decrease in both categories of crashes occurring at the rotary: total number of crashes; as well as, those crashes resulting in \$1,000 of property damage, injury or fatality. However, more data is needed to validate the statistical significance of these findings, and further study will be pursued in future years as additional data becomes available.

Even though crashes at the Greenfield Rotary continue to be of the same type of crashes that occurred prior to the installation of the improvements (i.e. rear-end collisions), promising early results indicate that the overall number of crashes has dropped substantially. Due to the limited availability of data and the short amount of time since the improvements were completed, it is important to continue monitoring this area so that a more statistically significant set of data can be analyzed in the future.

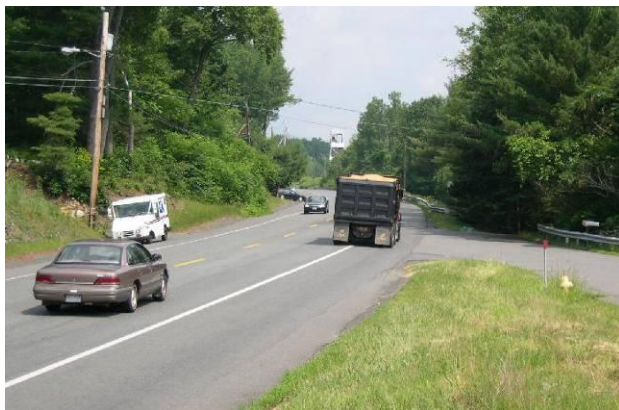
Westbound on Route 2, on Greenfield Mountain

- Limit left turns in and out of the Big Y Plaza Driveway onto Route 2.
- Continue two lanes on Route 2 in the westbound direction past the Home Depot driveway.
- Restripe Route 2 up Greenfield Mountain to provide a climbing lane for westbound slow traffic.
- Continue to monitor crash and traffic conditions at the Colrain-Shelburne Road intersection with Route 2 to determine the need for a dedicated right turn lane on in the westbound direction of Route 2.
- Add a protected left-turn lane to the westbound direction of Route 2 at its intersection with South Maple Street.
- Work with MassDOT District 1 and the Town of Charlemont to develop traffic calming measures and pedestrian improvements through the Village Center.
- Identify and investigate areas experiencing multiple lane departure crashes.

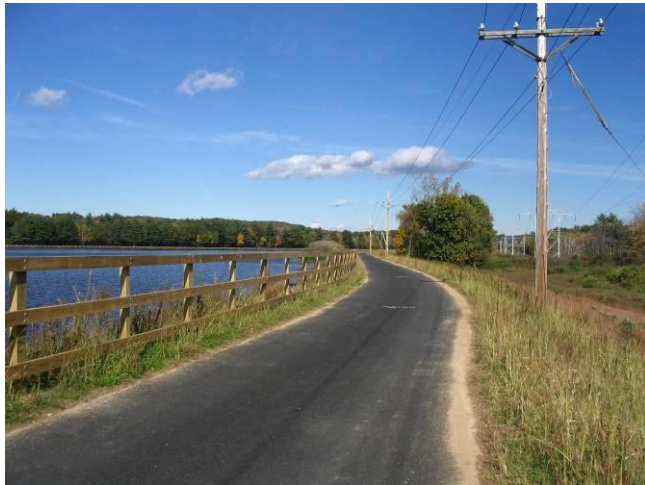
The Canalside Trail, in Turner's Falls

The Canalside Trail, which links the Towns of Montague and Deerfield, took specific precautions to address safety issues. This section of the Franklin County Bikeway is a 3.27-mile off-road bicycle path that travels along the Connecticut River Canal in Turners Falls and over a rehabilitated rail bridge into Deerfield. The bikepath incorporates fencing

along the canal, and pavement markings and signage along the roadway to identify the bicycle route.
